#### **Existing Corridor Infrastructure** 3.0

#### **Transportation Facilities** 3.1

526 Between North Charleston and West Ashley

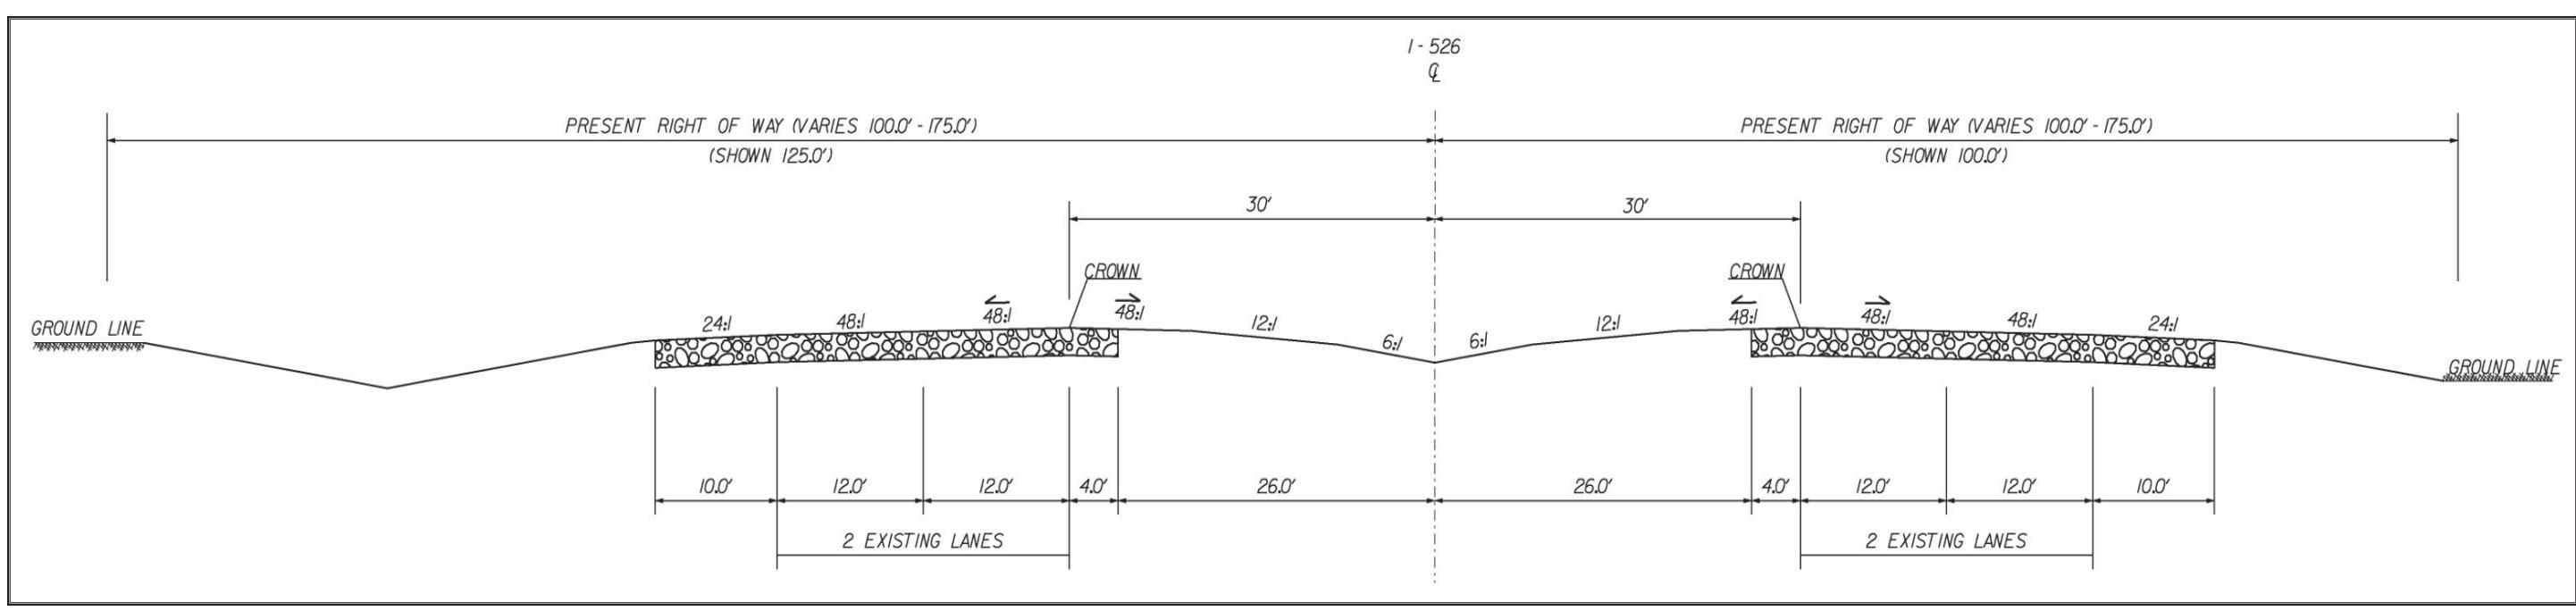
Exhibit 3-1: Typical I-526 Cross-Section, west of Rivers Avenue

The I-526 roadway section is a four-lane, divided expressway, generally having a 60-foot median measured between edges of the travel lanes that is illustrated in Exhibit 3-1. A cable median barrier separates both travel ways to prevent head-on collisions. The speed limit along I-526 is 60 mph from US 17/Savannah Highway to north of International Boulevard, 55 mph from north of International Boulevard to east of Rivers Avenue, and 60 mph east of Rivers Avenue. There are three geometric concerns with potential design issues that were identified: adequate clear zone, ramp lengths, and vertical curve speed. The locations of these potential issues are shown in the Environmental/Design Map series in the Existing Conditions Report for the I-526 Corridor Analysis.

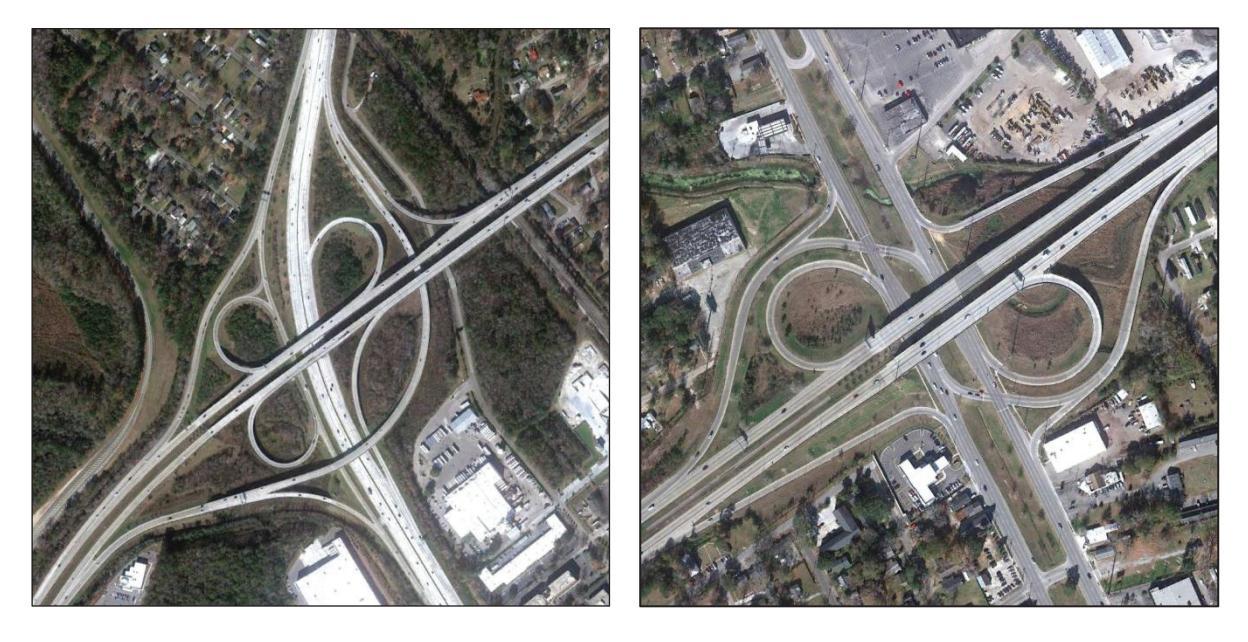
Exhibit 3-2: I-526 Interchanges with I-26 (left) and Rivers Avenue (right)

I-526 & US 52 (Rivers Avenue): This interchange is a partial cloverleaf design with loops in the southeast and northwest guadrants, as shown in Exhibit 3-2. The left turns from Rivers Avenue to I-526 in both directions are signalized to accommodate double left turns onto the ramps.

1-26 & 1-526: This interchange has a directional ramp from 1-526 eastbound to 1-26 westbound, and loop ramps in the other three quadrants of the interchange, as shown in Exhibit 3-2. There is a collectordistributor (CD) road on I-26 eastbound to accommodate the movements from I-26 eastbound to I-526 eastbound and from I-526 westbound to I-26 eastbound.

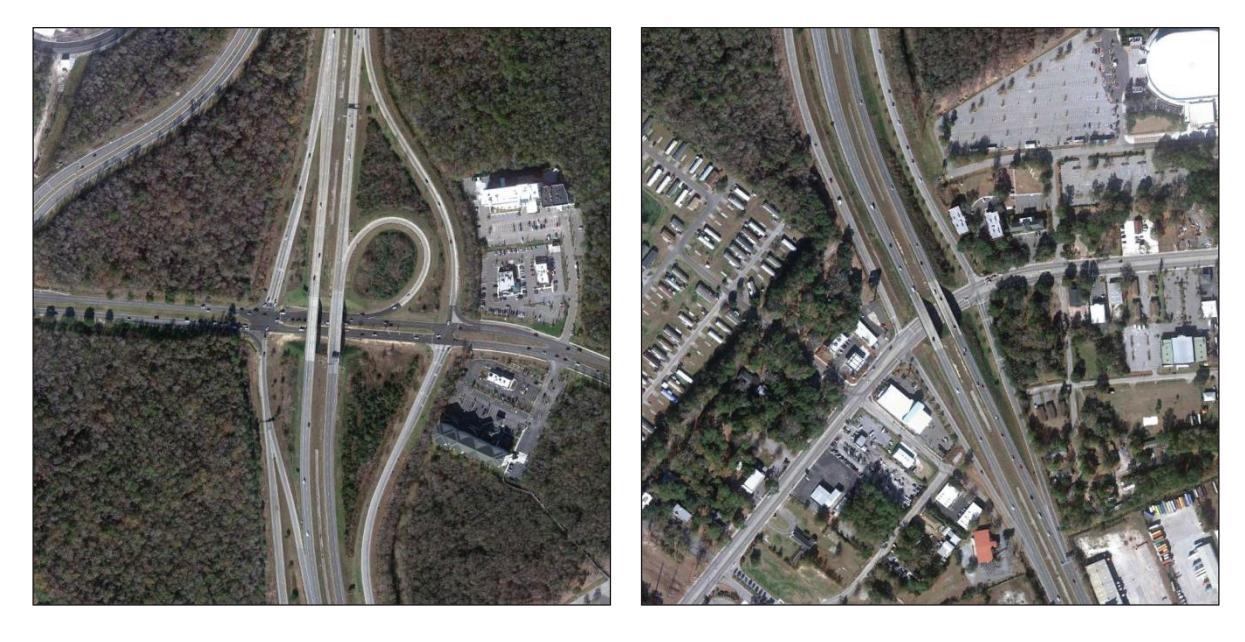
Exhibit 3-3: I-526 Interchanges with International Boulevard (left) and Montague Avenue (right)

**I-526 & International Boulevard/Montague Avenue:** This interchange, shown in Exhibit 3-3, is essentially a split diamond with a CD between International Boulevard and Montague Avenue. Eastbound I-526 traffic to Montague Avenue and International Boulevard exits at Montague Avenue to a signalized intersection. Traffic to International Boulevard passes through the signal and continues on the CD road to International Boulevard. A similar situation exists for westbound traffic exiting to Montague Avenue. There is also a loop from I-526 eastbound to International Boulevard westbound towards Charleston International Airport.

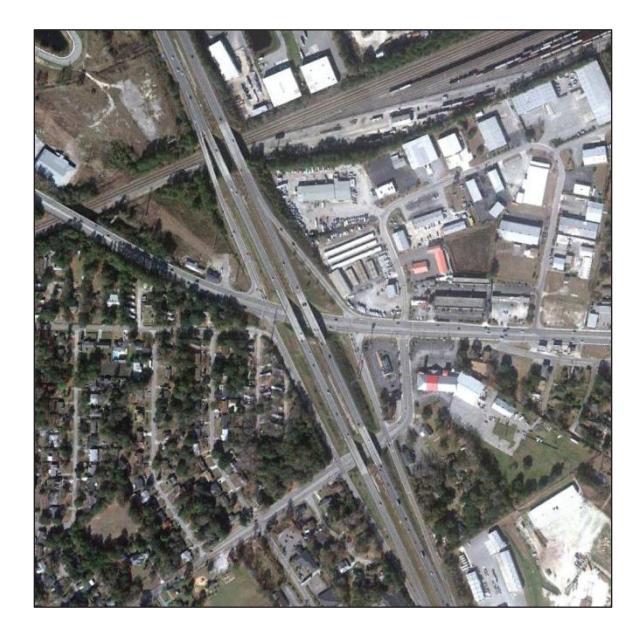
Exhibit 3-4: I-526 Interchange with Dorchester Road/Paramount Drive

I-526 & Dorchester Road/Paramount Drive: This interchange, shown in Exhibit 3-4, is a split diamond serving Dorchester Road and Paramount Drive. Eastbound I-526 traffic exits at Paramount Drive to a signalized intersection. Dorchester Road traffic proceeds through the signalized intersection to a signal at Dorchester Road. A similar situation exists for westbound traffic exiting to Paramount Drive. There is also a slip ramp onto the westbound ramp to I-526 from an adjacent subdivision.

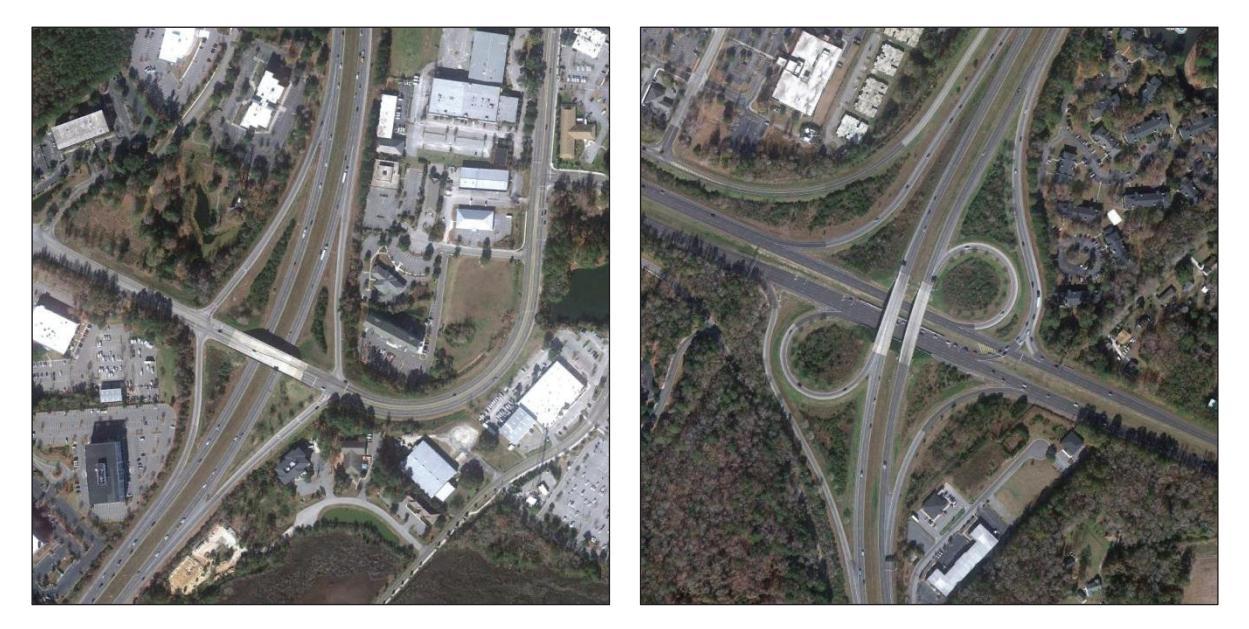
Exhibit 3-5: I-526 Interchanges with Leeds Avenue (left) and Paul Cantrell Boulevard (right)

I-526 & Leeds Avenue: This interchange, shown in Exhibit 3-5, is a diamond with signalized intersections at each ramp terminal. At this interchange, I-526 passes under Leeds Avenue. Leeds Avenue has a posted speed limit of 40 mph, and the 2011 AADT was 7,800 west of I-526 and 14,000 east of I-526.

I-526 & Paul Cantrell Boulevard: This interchange, shown in Exhibit 3-5, is a partial cloverleaf design with loops serving the movements from I-526 eastbound to Glenn McConnell Parkway northbound and I-526 westbound to Paul Cantrell Boulevard southbound. The ramp serving the movement from Paul Cantrell Boulevard to I-526 eastbound is two lanes for a short distance to accommodate double left turns.

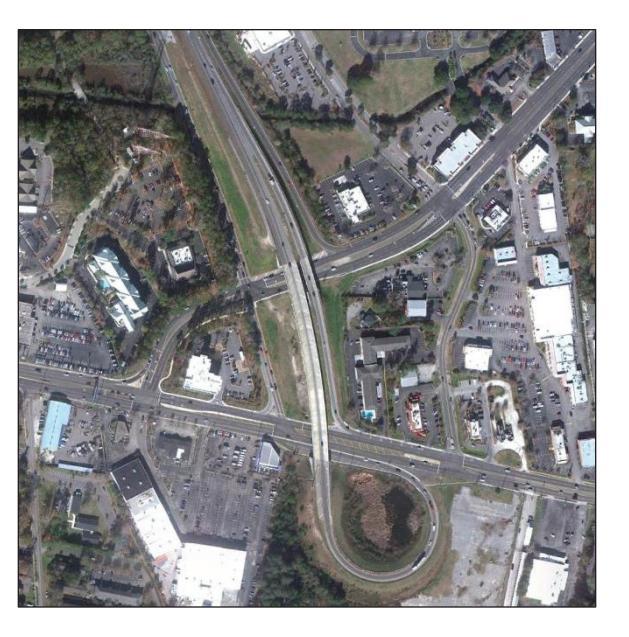
Exhibit 3-6: I-526 Interchange with Sam Rittenberg Boulevard and US 17/Savannah Highway

I-526 & Sam Rittenberg Boulevard: This interchange is a half diamond due to the close proximity to US 17 south, as shown in Exhibit 3-6. There is an on ramp from Sam Rittenberg Boulevard southbound to I-526 eastbound and an off ramp from I-526 westbound to Sam Rittenberg Boulevard, as all westbound I-526 traffic approaches Sam Rittenberg Boulevard at a signal controlled at-grade intersection. Sam Rittenberg Boulevard has a posted speed limit of 45 mph, and the 2011 AADT was 27,800.

I-526 & US 17/Savannah Highway: This interchange, shown in Exhibit 3-6, is a partial diamond with a loop serving the northbound US 17 to eastbound I-526 movement. US 17/Savannah has a posted speed limit of 45 mph, and the 2011 AADT was 43,300 west of I-526 and 38,100 east of I-526.

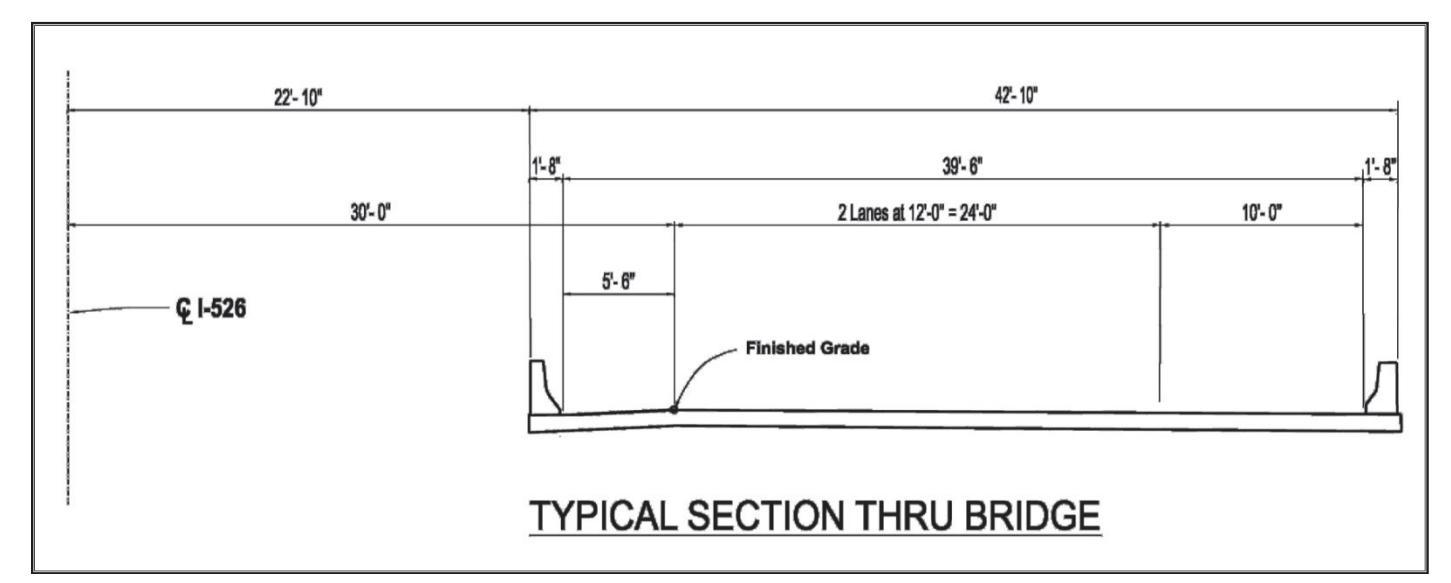
Along the length of the I-526 corridor from Rivers Avenue to US 17/Savannah Highway, there are a total of 35 bridge structures including one bridge over I-526 and one bridge length culvert, over 20 feet along the roadway, under the Interstate. Table 3-2 provides an overview of the structures along the corridor including year constructed, clearances, sufficiency ratings, and application of seismic design. The mainline bridges were constructed to carry two travel lanes and with a 39.5-foot roadway width, as shown in Exhibit 3-7.

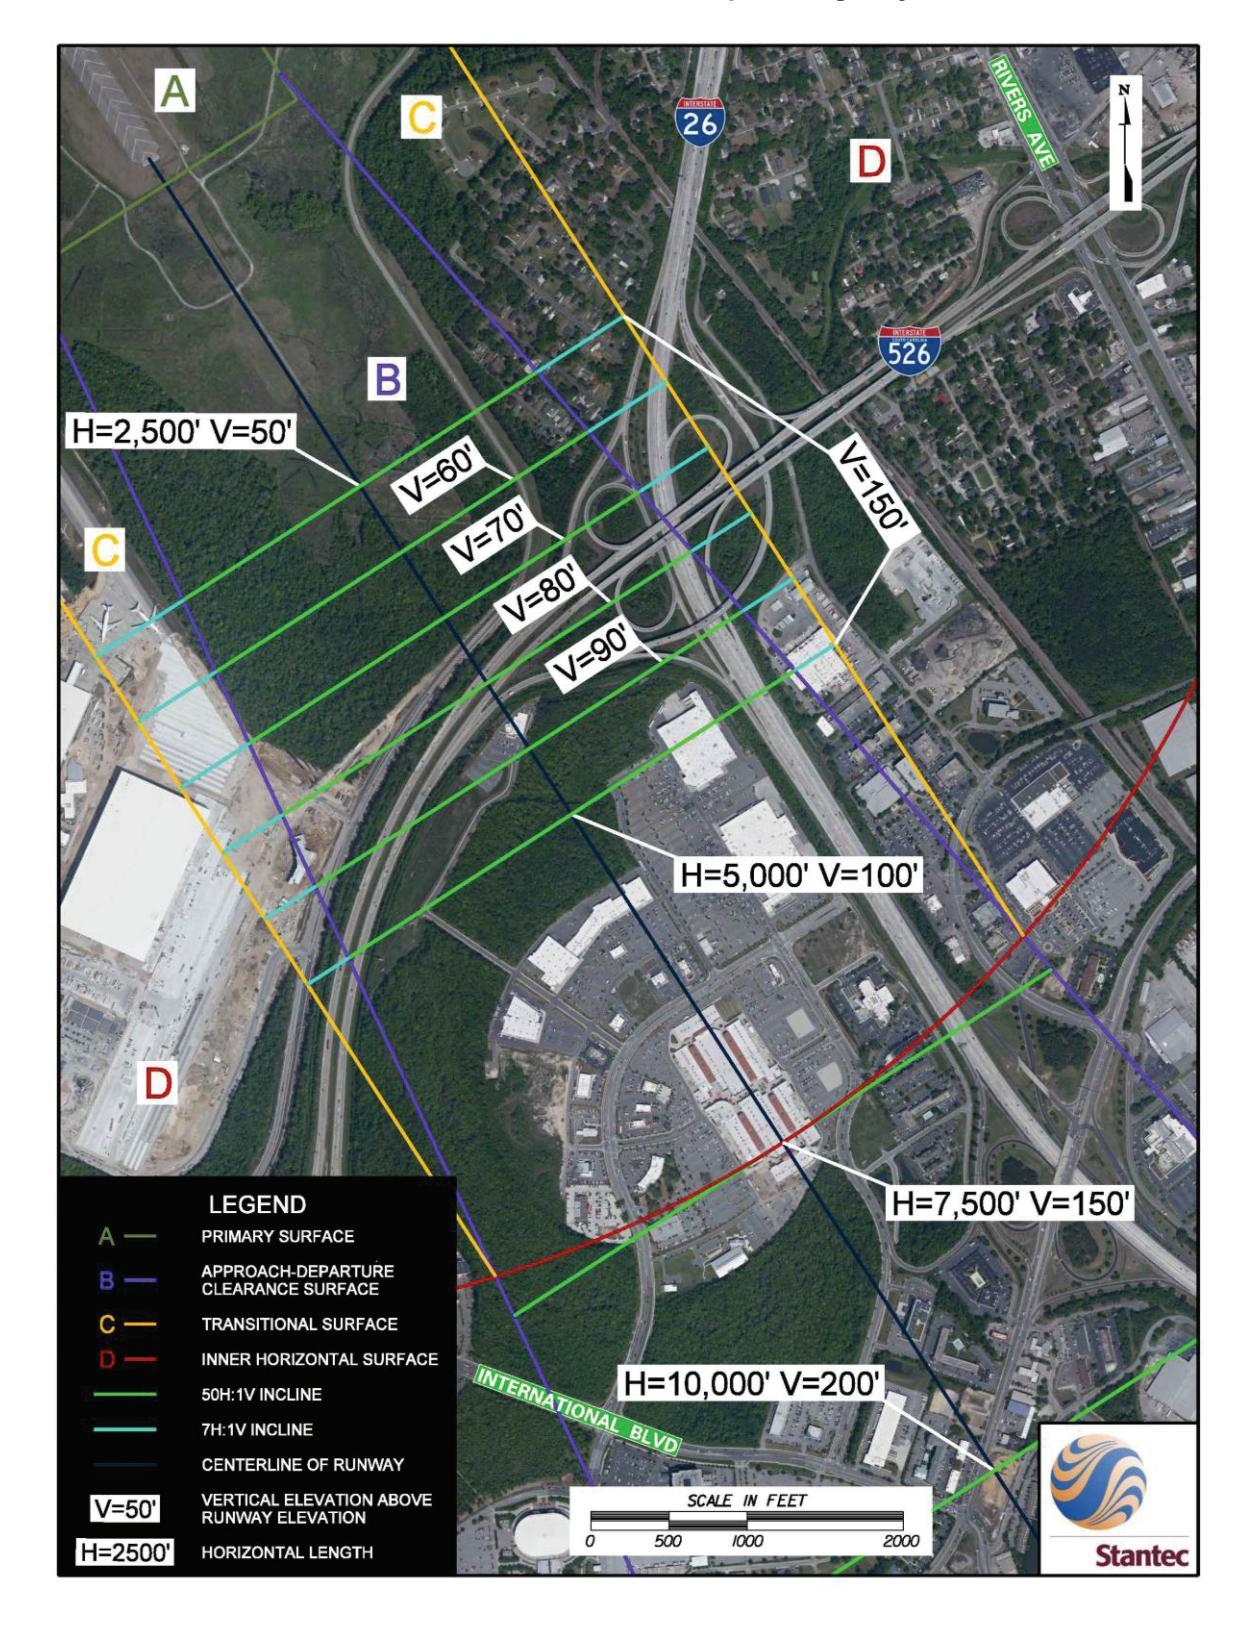
# Exhibit 3-8: Charleston International Airport Imaginary Surfaces

A schematic illustrating the Charleston International Airport imaginary surfaces affecting the I-26 & I-526 interchange is shown in Exhibit 3-8. The schematic indicates height restrictions from approximately 65-feet above the Runway 33 elevation in the northwest guadrant of the interchange to 150 feet on the eastern portion of the interchange area, which were considered in the development of conceptual improvements in the area.

The west side of the I-26 & I-526 interchange falls within the "Approach-Departure Clearance Surface" which begins 400 feet beyond the end of Runway 33 of Charleston Airport. The surface is an inclined plane with a slope of 50:1 up to an elevation of 500 feet above the airfield elevation. The east side of the I-26 & I-526 interchange falls within the "Inner Horizontal Surface" that has an elevation of 150 feet and the "Transitional Surface" that connects the "Approach-Departure Clearance Surface" to the "Inner Horizontal Surface" at a slope of 7:1.
